WORLD PUMPS

Number 420
September 2001

**IMPROVING PUMP
PERFORMANCE & EFFICIENCY
WITH COMPOSITE WEAR
COMPONENTS**

BY JONATHAN PLEDGER

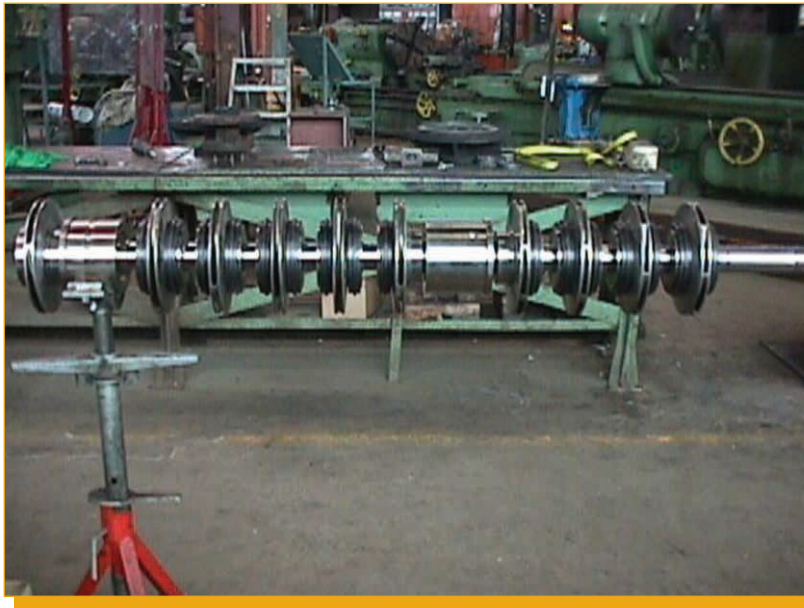
Figure 2. A small vertical turbine pump.

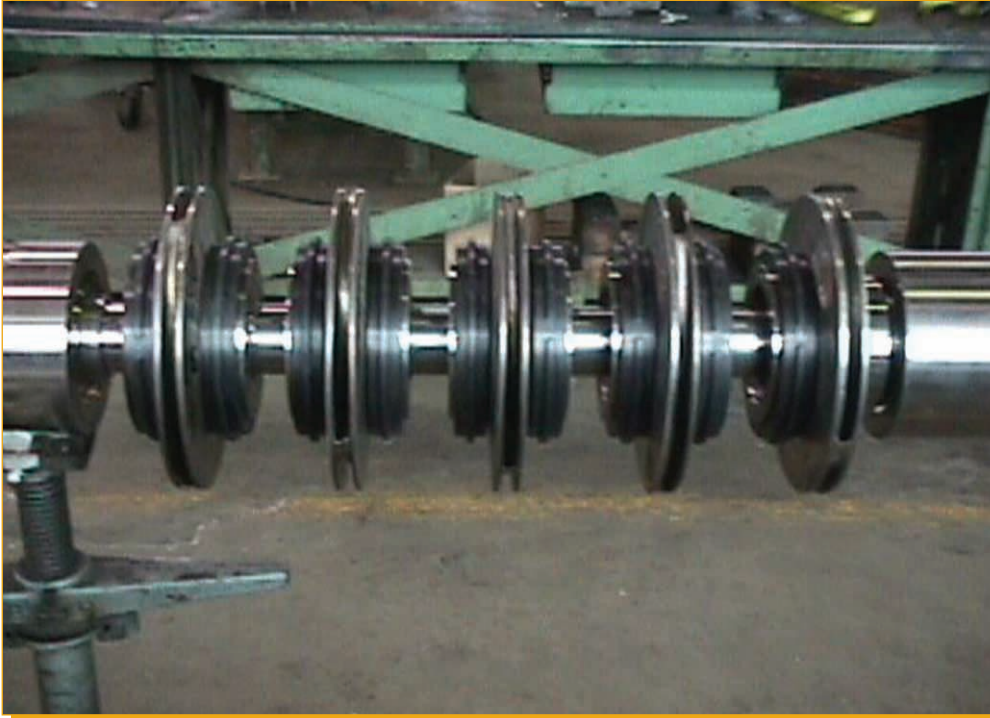
Figure 3. A large vertical turbine pump.

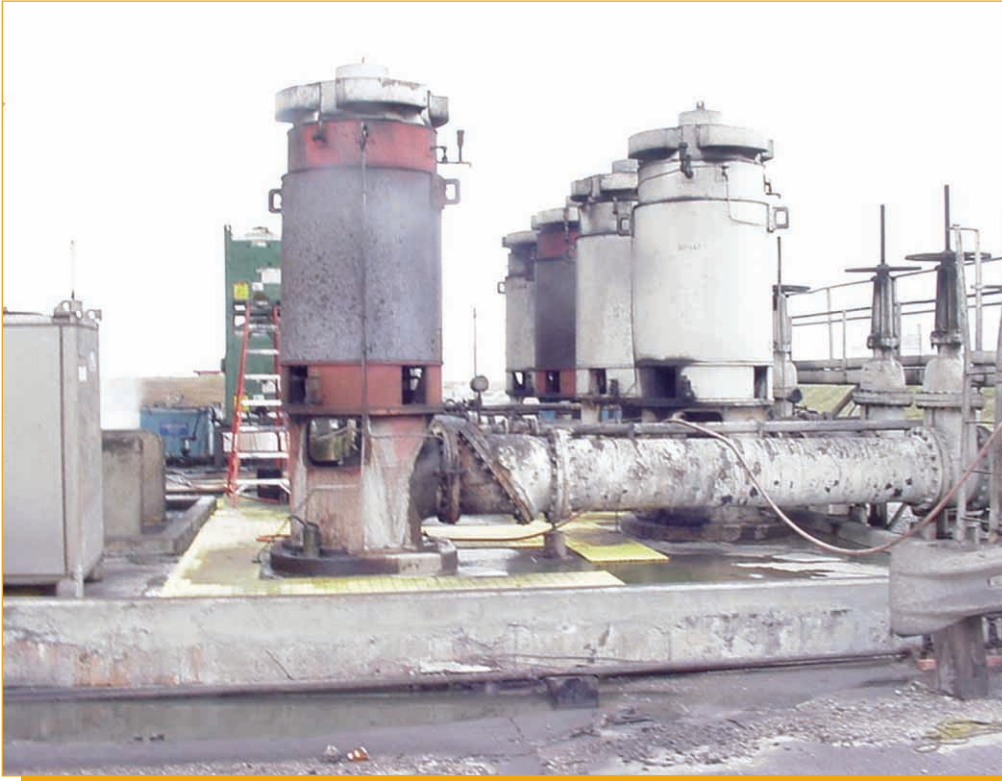
The vertical cooling tower is one of a group that ran bronze bushings and only lasted six months. Composite wear components were installed and several of these have been in service for over three years.
